The Fall Kill Streamwalk

A Visual Assessment of the Fall Kill through its Watershed

November 2008

Conducted by the Fall Kill Watershed
Committee

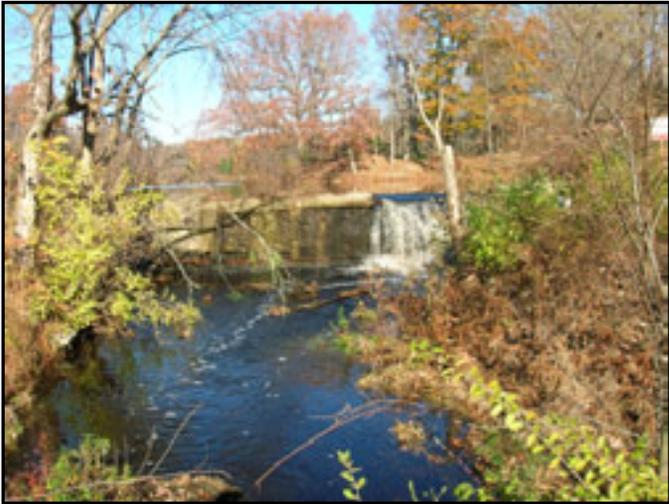
Left: Beginning of Victory Lake segment showing existing dam.

In general, the west bank of the creek consists of a wide buffer dominated by a mixture of hardwood forest and shrubs. Several large wetlands were observed on this side of the creek. The east side of the creek has less of a buffer and is dominated by shrubby vegetation as well the invasive species, reed canary grass and phragmites. Thick shrubby vegetation was noted on both side of the stream in several spots to the extent that it completely enclosed the stream channel. As the stream leaves the Camp property it reaches the second impounded lake near the Reach Out Worship Center on Crum Elbow Rd. This lake is impounded by a dam approximately 1.35 m high and 12.5 m wide.

- The multiple culvert design of both crossings located in the segment may cause problems during flood events due to restricting the width of the stream channel and the formation of debris dams. If at all possible, reconstruction of both of these bridges would prevent future flooding, erosion and possible damage to both access roads.
- The potential management of the two impounded lakes to store water during flood events should be investigated, as flooding in downstream developments has been an increasing problem in recent years.

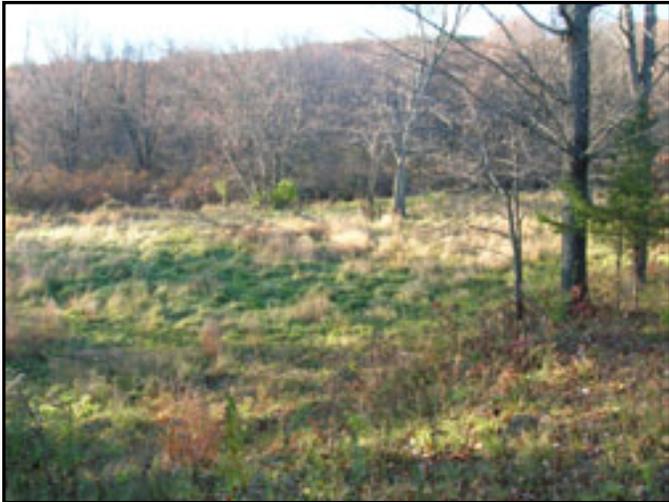
Right: Active floodplain area, possible location for streamside plantings adjacent to Victory Lake Segment.

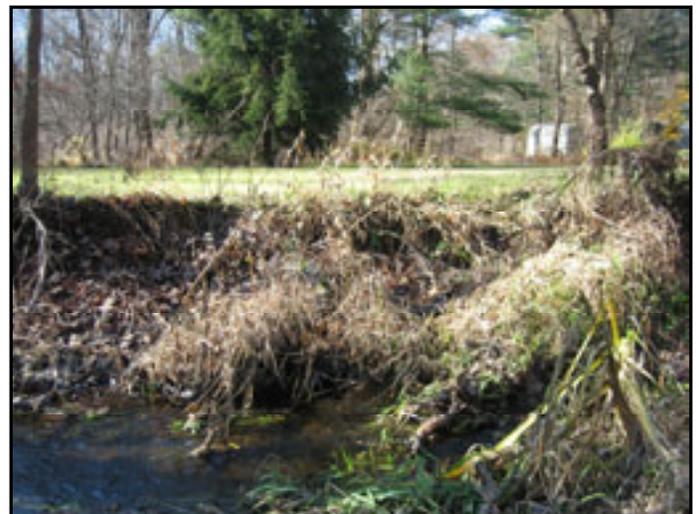
Above: A section of the creek near a mowed lawn with unstable banks.

There were two areas where the buffer had been removed. The section of the segment near Cream Street, there is lawn on the east side of the stream. The owner of this property stated that part of the lawn gets very wet in the spring and hosts many frogs and snakes. Further downstream, there is an area where the west side of the bank was at one time stabilized with a stone wall, and there is lawn bordering the stream in that area. A pump was observed, apparently drawing water out of the creek for an unknown purpose.

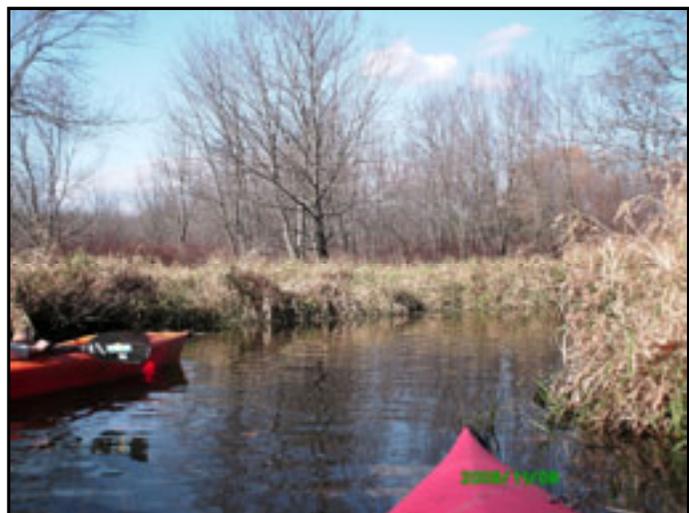
The segment successfully kayaked appeared to be in good condition considering its proximity to homes and yards. There was a healthy stand of buttonbush observed; however the vegetation along the banks was dominated by the invasive species reed canary grass. The stream flowed at a relatively low gradient, and high levels of sediment were observed, with few rocks or gravel present in the substrate. Few riffles were present, but where they were, sediment embeddedness did not seem to be an issue.

Right: A section of the creek on National Park Service property, buffer is dominated by the invasive species Reed-canary grass.

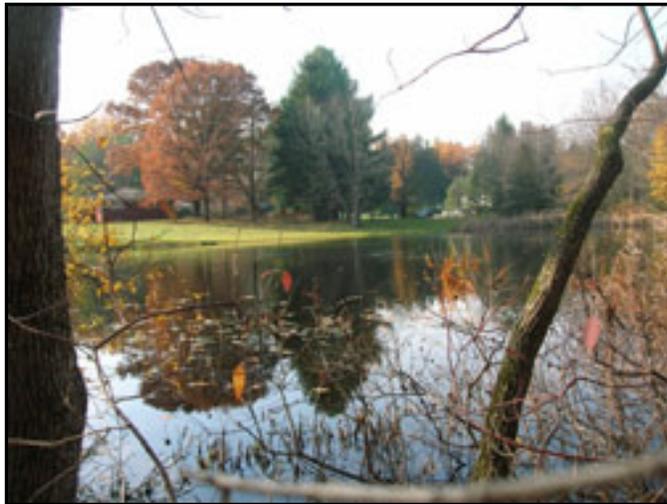
Left: Residential homes near an impounded section of the Fall Kill, Hyde Park.

Survey Parameter	Score	Site Notes
Channel Condition	3	Bulkhead and riprap present along banks adjacent to residential property; several manmade and natural dams present
Hydrology	8	Anecdotal evidence that stream had flooded over banks twice in past year; good connection with floodplain
Riparian Zone	1	Mowed lawns up to edge along residential property
Bank Stability	5	Banks along residential property show indications of slight erosion
Water Appearance	9	Water clear but had a dark color
Nutrient Enrichment	NA	Not evaluated due to time of year
Barriers to Fish Movement	1	Dams present in segment
Instream Fish Cover	5	Presence of logs and large woody debris, deep pools, overhanging vegetation, and isolated/backwater pools
Pools	7	Several deep pools observed
Insect/Invertebrate Habitat	3	Presence of fine woody debris and submerged logs; stream generally lacking a rocky bottom for much of the segment.
Canopy Cover	10	Excellent canopy cover for most of the length, even residential lawns had large canopy trees present

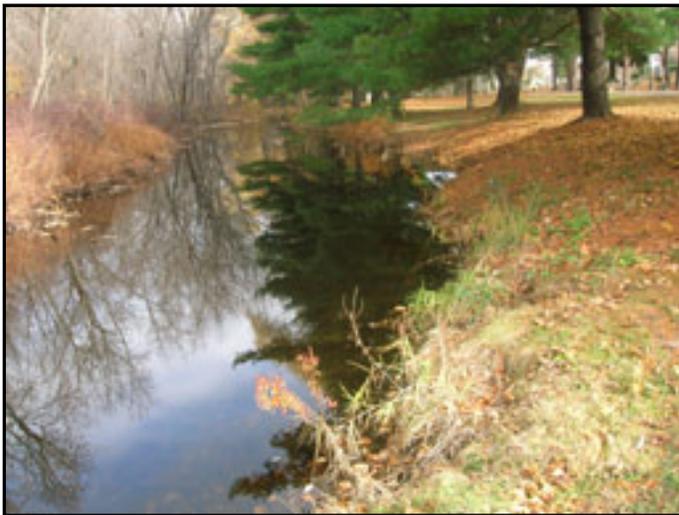
Left: A section of the creek through St. Peter's Cemetery, Town of Poughkeepsie

Survey Parameter	Score	Site Notes
Channel Condition	5	Channel lined with stone walls and large cut stones, large piles of recently dumped fill along banks that would restrict flooding
Hydrology	9	Evidence of active flooding recently in floodplain
Riparian Zone	2	No riparian buffer along banks on cemetery side for most of the length; beyond the active cemetery and automotive dump, buffer increases and becomes young forest
Bank Stability	5	Slight erosion present in some areas with unstable banks
Water Appearance	5.5	Very clear water throughout except for one discharge area with murky water and strong odor
Nutrient Enrichment	NA	Not evaluated due to time of year
Barriers to Fish Movement	1	Dam at north end of segment
Instream Fish Cover	10	Presence of log and large woody debris, deep pools, overhanging vegetation, boulders and cobbles, riffles, undercut banks, thick root mats, and isolated/backwater pools

Moving north from the starting point the east side of the stream was primarily dominated by property owned by St. Peter's Cemetery. For about ½ the segment length this side of the stream has only a narrow mowed grass buffer and paved road with several large mature trees. One storm drain was observed discharging directly into the stream. The remainder of the segment is not actively managed as a cemetery. There is a dirt access road following the stream with active dumping of fill material occurring between the road and the creek, encroaching directly on the floodplain. In addition, a drainage channel from a nearby large wetland, just northeast of the creek, is discharging directly into the stream channel. Further north there appears to be an old dumping site about 30 m from the stream channel. The floodplain along this section appears to have flooded recently, and an orange discharge appears to be leaching into the stream channel in the vicinity of this area.

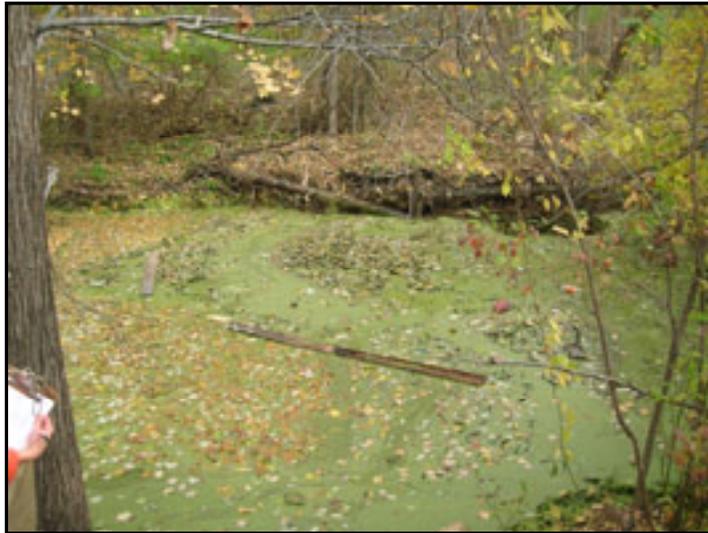
Left: A debris dam and excessive growth of duckweed indicating possible nutrient inputs.

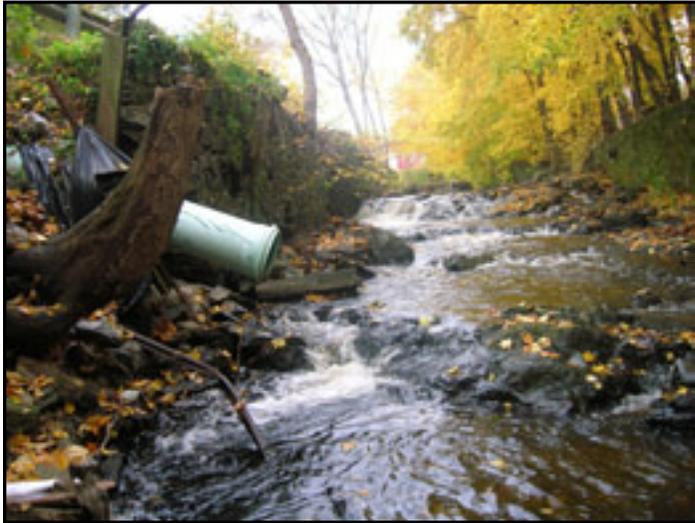
Left: Evidence of dumping in the Fall Kill in the City of Poughkeepsie.

Insect/Invertebrate Habitat	7	Presence of submerged logs, cobble, boulders, coarse gravel as well as cinder blocks, bricks and other garbage that can be considered invertebrate habitat
Canopy Cover	8	Between 40-80% canopy cover; large mature street trees line creek in some stretches of the segment
Embeddedness	9	Cobbles 20% embedded
Level of Trash	1	High levels of litter and large debris
